Professional Building Inspection Service

6824 S Spanish Cir W, Centennial

November 4, 2010

Report Overview

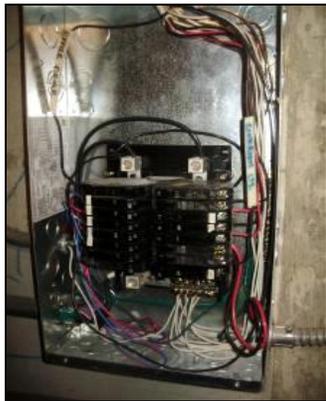
Sub-Panel, Basement

- **Repair:** The auxiliary panels currently are supplied by either 50 or 60 amps. Based on the number of circuits in the sub-panels within the basement, larger sub-panels may be needed. A certified electrician should further evaluate the panels, and make necessary recommendations.
