RESIDENTIAL REPORT

1234 Main St. Centennial Colorado 80112

06/23/2021 9:00AM

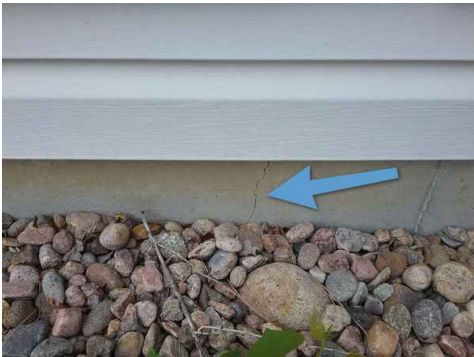
2.1.1 Foundation

EXHIBITS HAIRLINE VERTICAL/DIAGONAL CRACKING

The cracking may worsen allowing moisture intrusion. Monitor for further cracking. If the cracks widen have epoxy injected into the crack by a licensed waterproofing contractor.

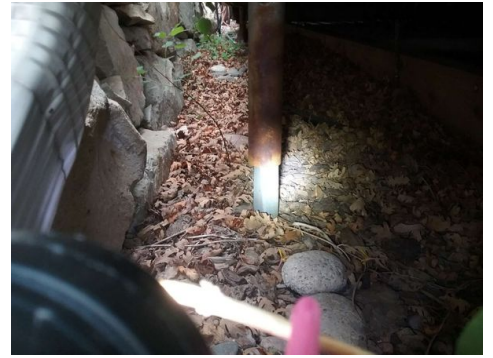
2.1.2 Foundation

FOOTER QUESTIONABLE

The back addition did not appear to have a foundation wall, and questionable footers. Without proper footers, the structure is more likely to move. Have a general contractor further evaluate the structure to determine if improvements are needed for integrity. The home owner should also be asked for any permits for the addition of this space.

Contact a qualified general contractor.

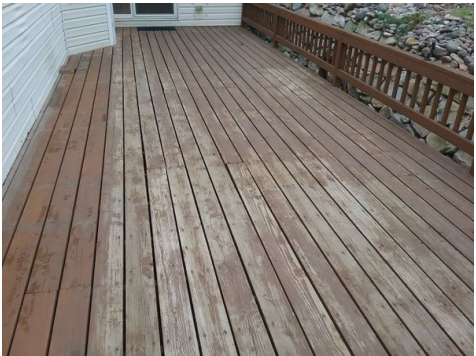
4.1.1 Decks, Balconies, & Pergolas

STAIN, PAINT OR SEALER HAS PEELED, FADED, MISSING OR BLEACHED OUT (MINOR)

Re-paint or stain the decking as needed.

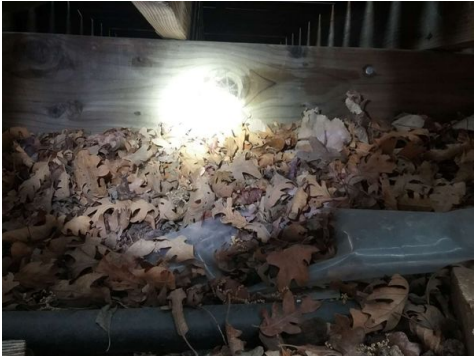
4.1.2 Decks, Balconies, & Pergolas

The soil may cause moisture damage to the wood. Monitor for wood deterioration. Should deterioration continue have repaired or replaced.

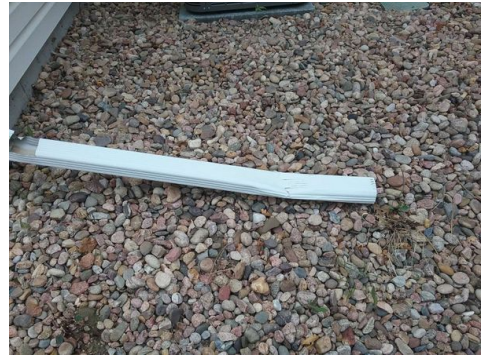
4.4.1 Roof Drainage Systems

**DOWNSPOUT EXTENSION
DAMAGED**

Reduced efficiency, allowing water close to the house. Replace extension as needed.

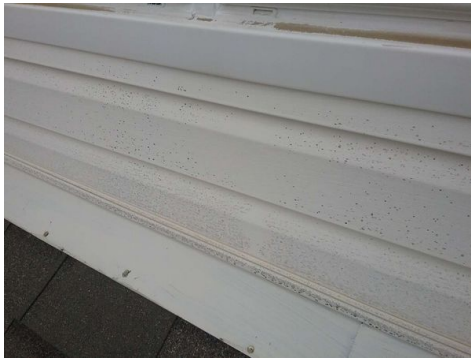
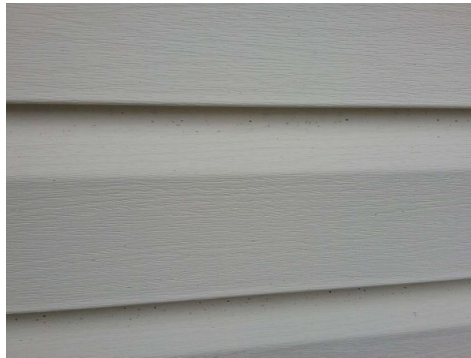
4.5.1 Siding & Trim

DISCOLORATION OF SIDING OBSERVED - SPOTTING

Discolored or "spotting" on the siding (typically the north side of the house) indicates moisture build-up on the siding that doesn't evaporate quickly, and turns into Microbial-like growth. Painting the siding with an exterior paint/primer is recommended where the discoloration is present.

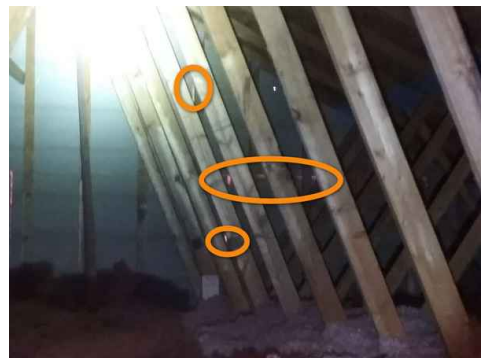
4.5.2 Siding & Trim

**HOUSE WRAP/MOISTURE
BARRIER NOT OBSERVED BEHIND SIDING**

Lack of a moisture barrier can allow water to penetrate the home's framing. Verify whether house wrap was installed during construction. As this is typically very costly to add if missing, verifying it is in place is recommended.

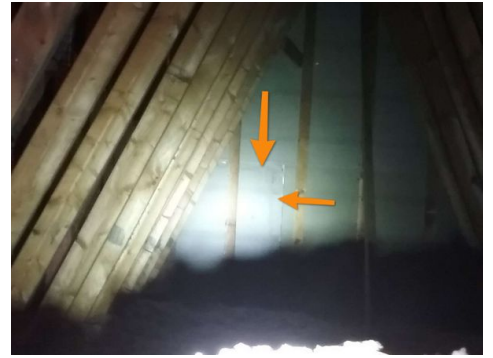
4.5.3 Siding & Trim

**MOISTURE INTRUSION -
MODERATE**

With moisture intrusion present, mold could grow and there could be moisture damage inside the house. Have a general contractor or mitigation company assess for the exterior damage, and the source of moisture intrusion and recommend repairs.

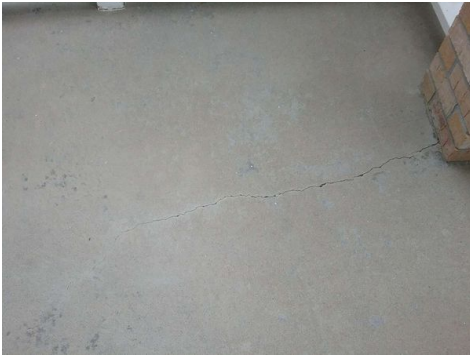
4.6.1 Walkways, Patios & Driveways

CONCRETE HAS MINOR CRACKS

All cracks in the concrete should be sealed with a concrete sealer to prevent future moisture entry.

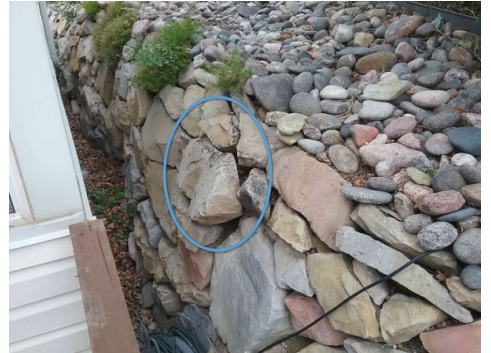
4.10.1 Fencing, & Retaining Walls

RETAINING WALL BRICKS OR STONE ARE MISSING

Primarily a cosmetic issue. Have repaired by qualified stone mason or landscaper.

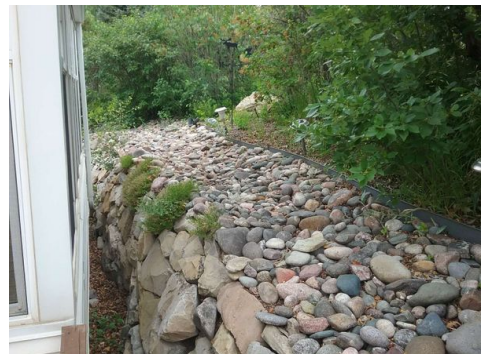
4.11.1 Vegetation & Grading/Drainage

DOES NOT HAVE A POSITIVE GRADE

Directing more moisture towards the foundation increases the risk of moisture intrusion. Monitor the area for moisture buildup. Should it arise, if possible, regrade the area to achieve a slope away from the building. If regrading is not possible, add drain tile to re-direct water away from the building. French drain systems can be beneficial as well. Also, consult with a licensed waterproofing professional.

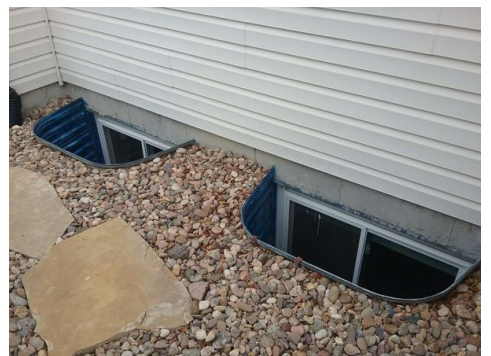
4.11.2 Vegetation & Grading/Drainage

DOES NOT HAVE A POSITIVE GRADE/EXTEND WINDOW WELL

Directing more moisture towards the foundation increases the risk of moisture intrusion. Improving grading in this area is recommended, which will entail extending 1 or more window wells. If regrading is not possible, add drain tile to re-direct water away from the house.

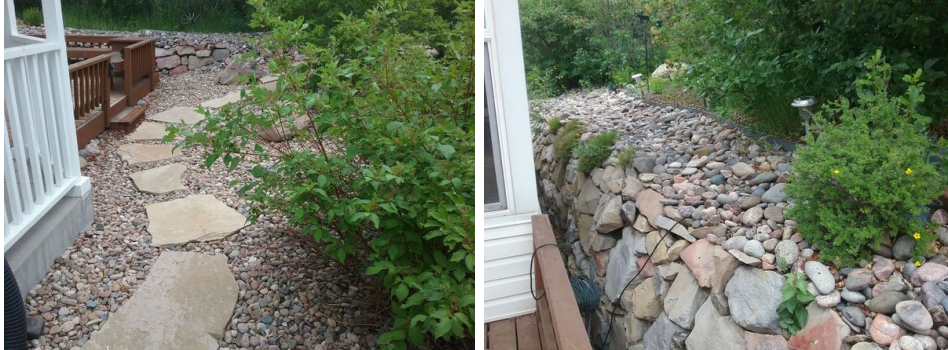
4.11.3 Vegetation & Grading/Drainage

FRENCH DRAIN SYSTEM RECOMMENDED

A French drainage system helps to move storm run-off from the back of the yard to the front of the house, and can reduce moisture issues with the house and yard. A landscaper should further evaluate installing a French drain system in the back/sides of the yard.

Contact a qualified landscaping contractor

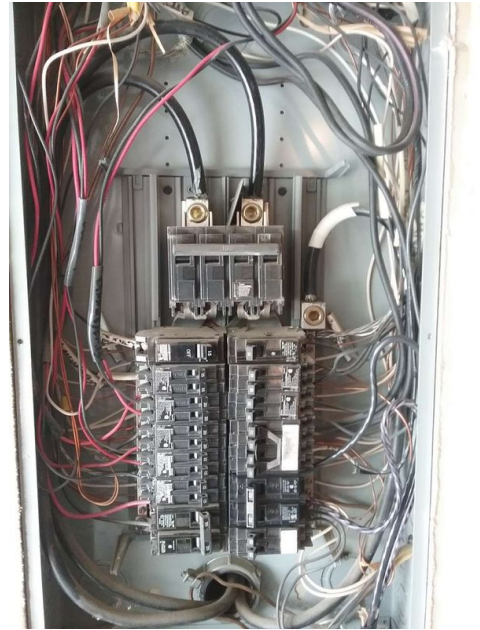
6.2.2 Main Electrical Service Panel

FULL PANEL

Recommend monitoring.

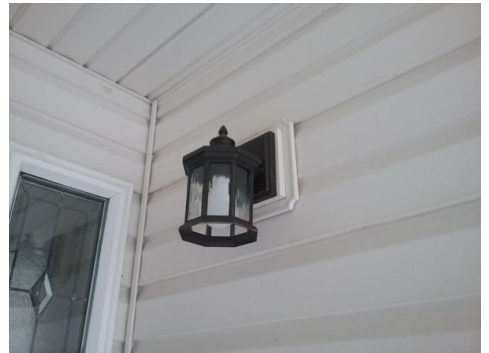
6.4.1 Lighting Fixtures

**NOT WORKING-BULB
BLOWN/ON A SENSOR**

The light(s) were not operable at the time of the inspection. If the bulbs are not blown or the unit is not on a sensor, the circuit should be repaired.

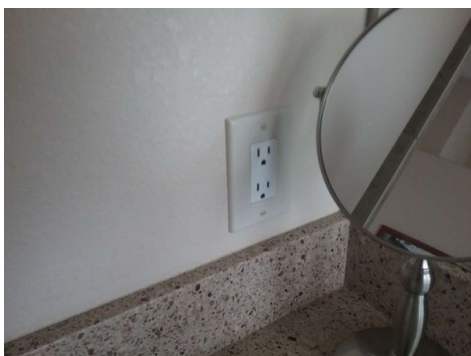
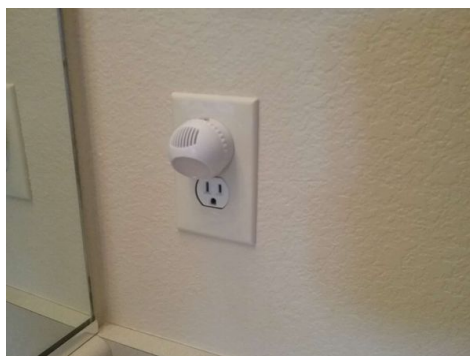
6.5.1 GFCI & AFCI

NOT PRESENT IN THE BATHROOMS WHERE THEY ARE REQUIRED

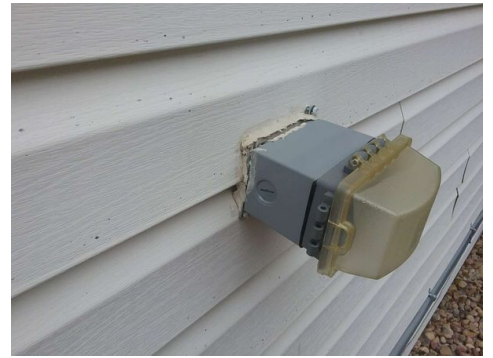
6.5.2 GFCI & AFCI

OUTLET IS LOOSE

Loose outlets can cause active wiring to touch the junction box, and spark or short-circuit the outlet. Properly secure the outlet.

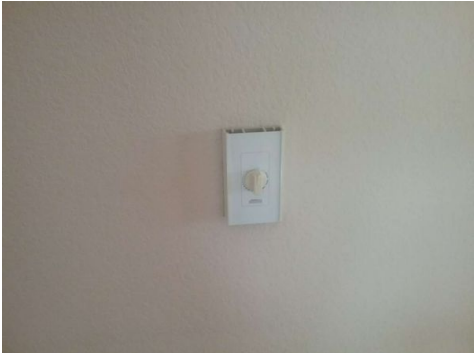
8.4.1 Whole House Fan

MISSING TIMER

Can cause gas fumes and carbon monoxide to be pulled up from the mechanical room. Install a timer switch for the whole house fan.

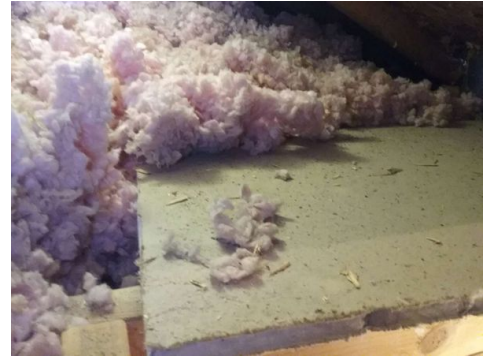
9.1.2 Insulation

HATCH NEEDS INSULATION

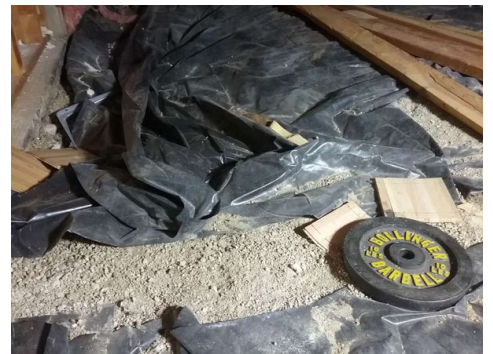
9.2.1 Ventilation

CRAWL SPACE MOISTURE BARRIER SHOULD BE FULLY SEALED

The moisture barrier in the crawl space should be fully sealed onto the foundation, and any seams should be sealed.

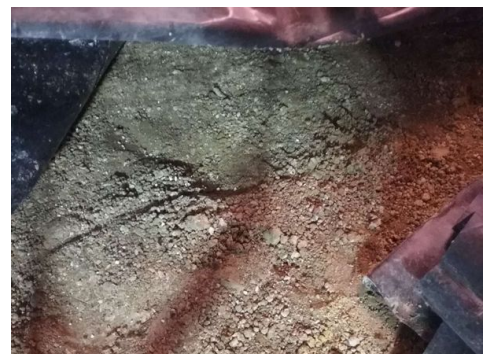
9.2.2 Ventilation

CRAWL SPACE SOIL HAS SOME MOISTURE/MUSTY ODORS AT THE TIME OF THE INSPECTION

Moisture in the crawl space can cause microbial-like growth to occur on the framing. The crawl space area should be properly vented, and all exposed areas of soil covered with a moisture barrier. See also any comments in the Exterior section of the report relating to keeping moisture away from the foundation.

Contact a qualified mold remediation contractor

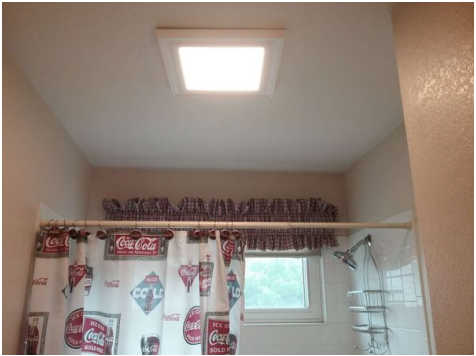
9.3.1 Bath/Kitchen Exhaust

**ADD EXHAUST FAN
W/WINDOW PRESENT**

Although there is a window that opens so an exhaust fan is not required, adding a fan that exhausts to the exterior is recommended.

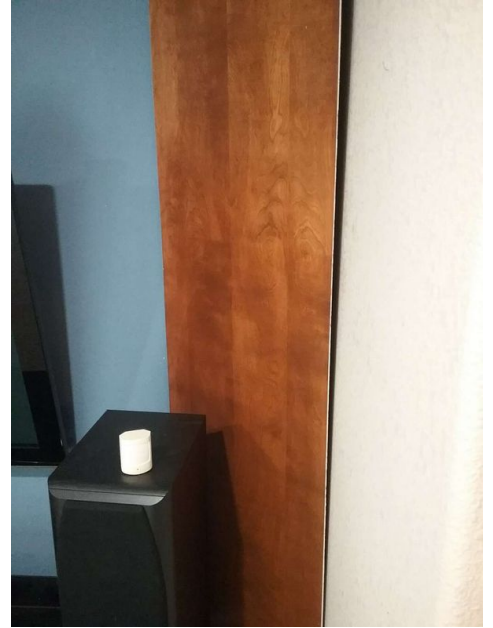
Main Water Shut-off Device

BLOCKED/NOT EASILY ACCESSIBLE

The main water valve was not able to be observed. Unknown whether a pressure regulator valve is installed. Recommend installing an access panel to provide quick access to water valve.

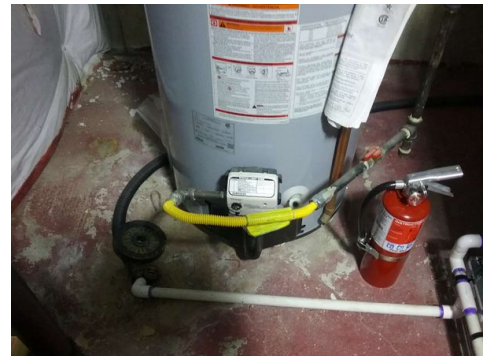
10.4.1 Hot Water Systems, Controls, Flues & Vents

The catch pan will help reduce damage to the home if the water heater leaks. A catch pan below the water heater should be considered, especially when replacing the unit.

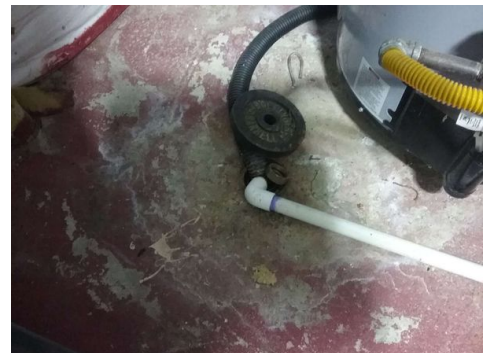
10.6.1 Sump Pump

This is not allowed in most areas, and is typically required to terminate to the exterior at least 4-5 feet away from the house. Have repaired by a qualified technician.

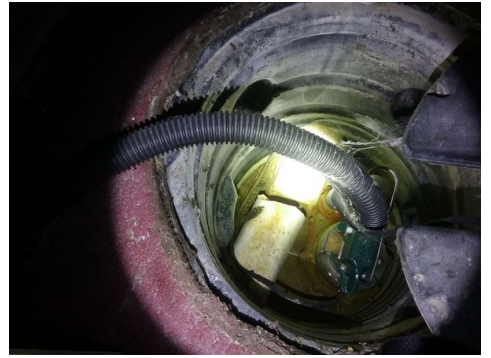
10.6.2 Sump Pump

This can cause the sump pit to not properly drain water that has come into the pit. The discharge piping should be replaced with piping that meets today's standards, and that contains a back-flow preventer. This should discharge to the exterior 4-5 feet away from the house.

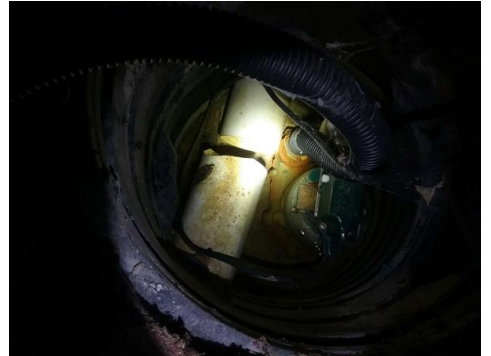
10.6.3 Sump Pump

FLOAT IS TOO HIGH OR PIT NOT DEEP ENOUGH

If the float is too high or the pit not deep enough, the water is not properly removed from the drain tile which could cause moisture intrusion. Adjust the float setting lower so it kicks on prior to water reaching the inlet drain, or possibly increase the depth of the pit, which can be difficult. It is likely in this situation, the pit depth will need to be increased.

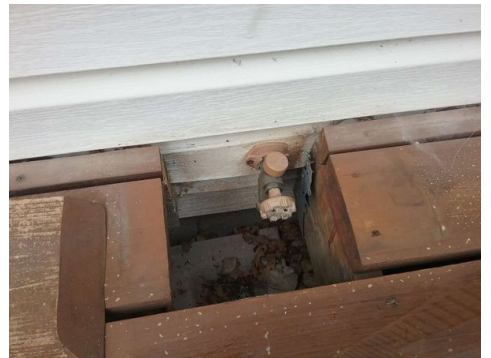
10.7.1 Hose Bib

HOSE BIB FROZEN/STUCK SHUT

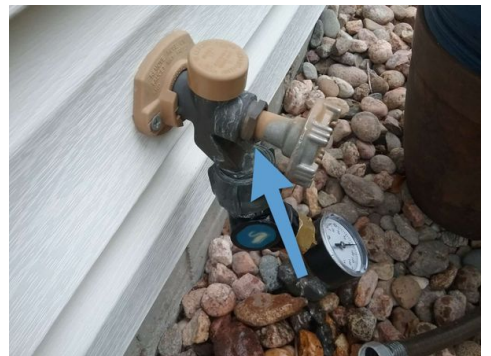
10.7.2 Hose Bib

LEAKING HOSE BIB WHEN OPERATED

The leak may cause water to drain near foundation and behind the wall cladding increasing the risk of moisture penetration into the house. Repair or replace the hose bibs if replacing the gasket is ineffective.

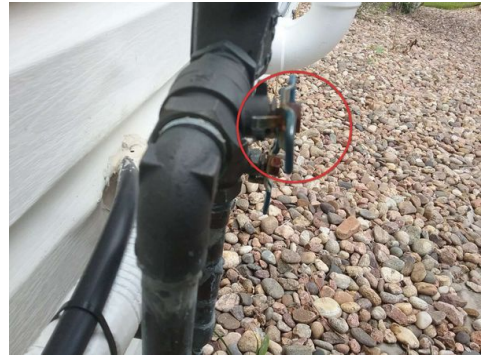
10.8.1 Irrigation System

LEAKY SPRINKLER SUPPLY

The supply line to the sprinkler system appears to be leaking, and should be further evaluated and repaired as necessary by an irrigation technician.

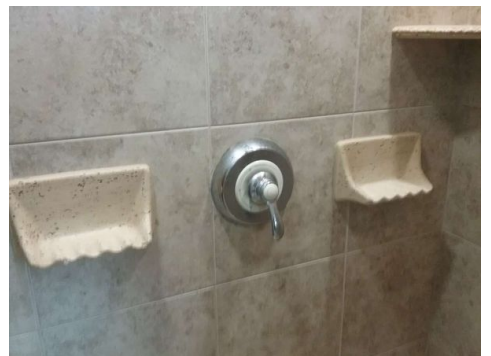
10.11.2 Shower/Bathtubs

FAUCET AND/OR MIXING VALVE ARE LOOSE

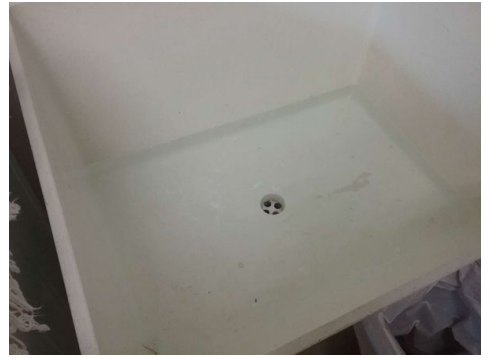
10.12.1 Sink

DRAINS SLOW

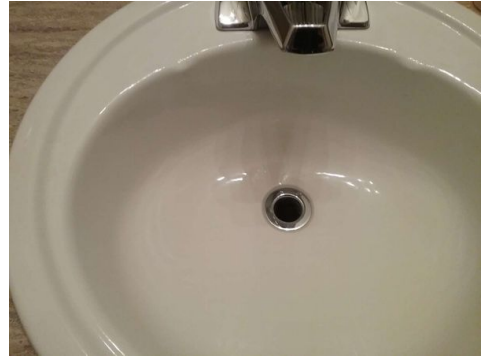
10.12.2 Sink

DRAIN STOP IS MISSING

Replace the drain stop.

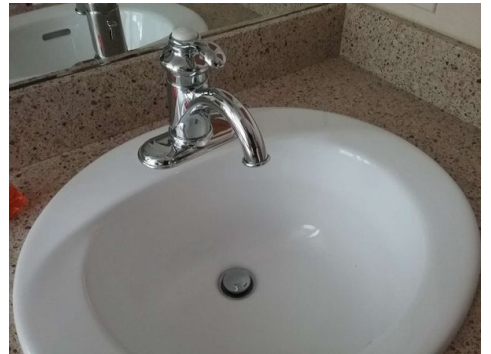
10.12.3 Sink

DRAIN STOP IS NOT CONNECTED TO THE DRAIN

Without a functioning drain stop, you will have to manually install and remove the drain stop to fill and drain the sink. Repair the drain stop.

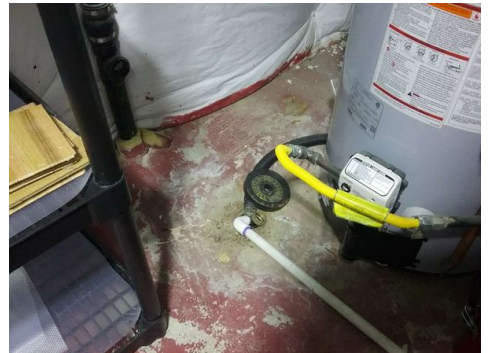
10.14.1 Floor Drain

FLOOR DRAIN HAS WATER MARKS INDICATING A POSSIBLE PAST LEAK

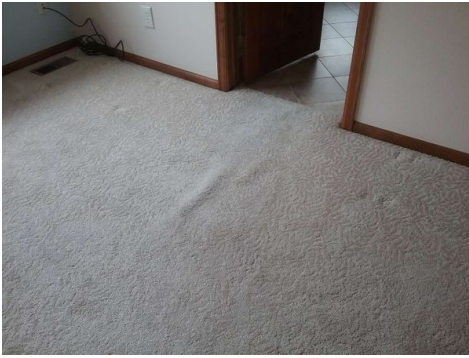
12.3.1 Floors

CARPET IS LOOSE

Have repaired by a carpet installer.

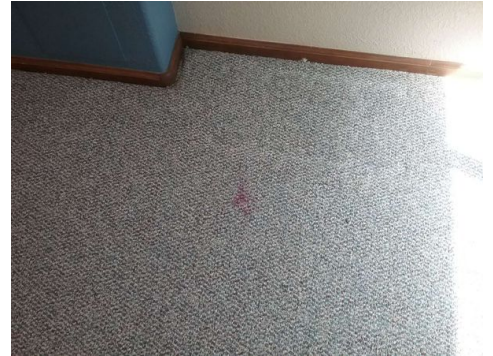
12.3.2 Floors

CARPET STAINS

Carpet had areas of staining or discoloration. Recommend a thorough steam clean by a qualified carpet cleaning company

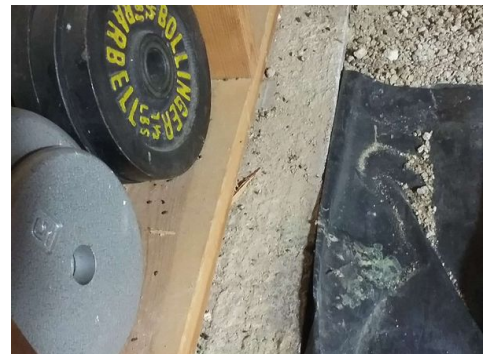
12.3.3 Floors

VERMIN ACTIVITY OBSERVED

Contact a qualified pest control specialist.

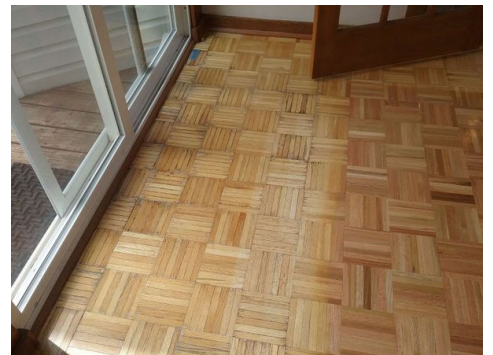
12.3.4 Floors

**WOOD FLOOR HAS
MODERATE WATER DAMAGE**

Water damage indicates past or present water leakage issues, which can sometimes be difficult to locate the source, and can cause rot and microbial-like growth in these areas. Areas of the wood floor that have water damage should be repaired or replaced by a flooring contractor. The home owner should be asked for more information about this area, and further evaluation as to the source of the water may be needed.

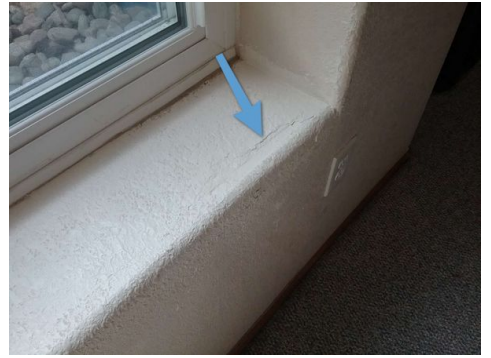
12.4.1 Walls

DRYWALL HAS DAMAGE

Beyond being an aesthetic issue, the gaps in the wall affect the thermal boundary of the home. Replace missing insulation and repair the damaged areas of the wall with drywall and compound.

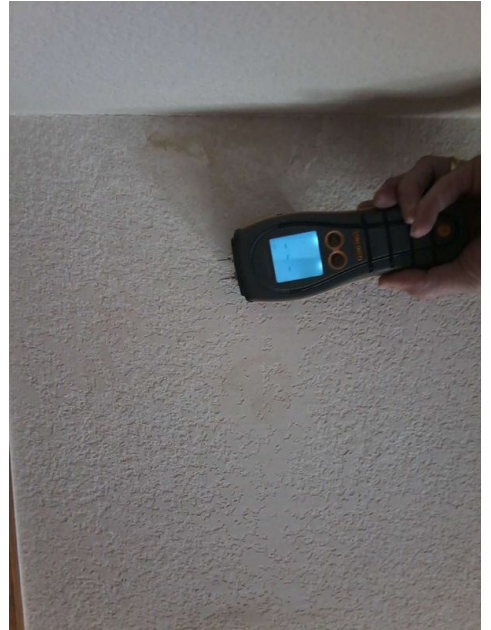
12.5.1 Ceilings

CEILING HAS EVIDENCE OF WATER DAMAGE AND/OR CRACKING - NO ACTIVE WATER

No moisture was observed using a moisture meter at the inspection. This area should be closely monitored for future leaks. No repairs are needed at this time. The home owner should be asked for additional information regarding the cause of the stains, and specific repairs completed.

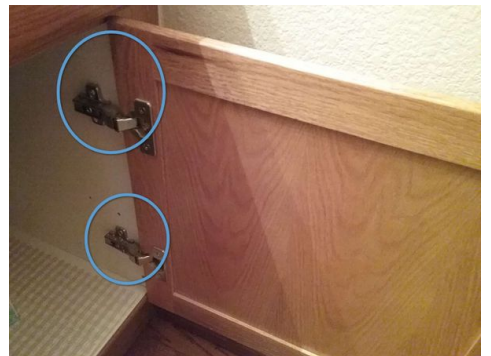
12.7.1 Countertops & Cabinets

HINGES ARE LOOSE, DAMAGED OR MISSING

May not open or close properly. Repair or replace hinges.

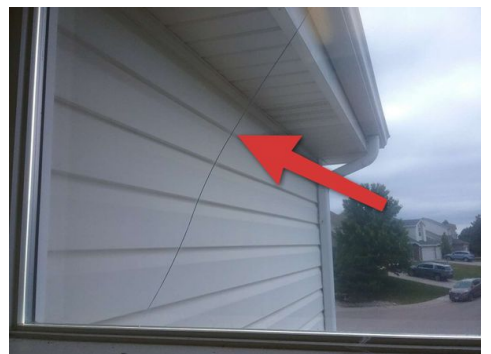
12.9.1 Windows

GLASS PANE IS CRACKED OR BROKEN

The cracks expose sharp edges and reduce protection from the elements. Replace the glass.

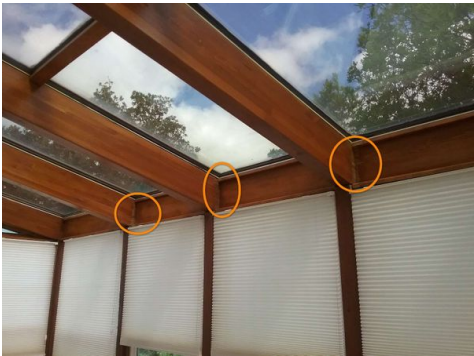
12.9.2 Windows

PAST WATER INTRUSION EVIDENT
