This summary represents a partial list of observations made at the time of the inspection. This section is provided as a convenience to help navigate to more detailed information found in the body of the report. It is organized to indicate the significance of the observation. It no way constitutes a recommendation of what should be negotiated as part of inspection resolution.

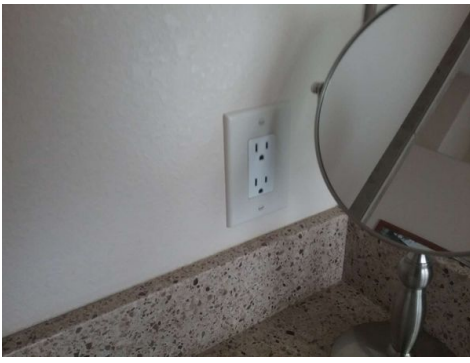
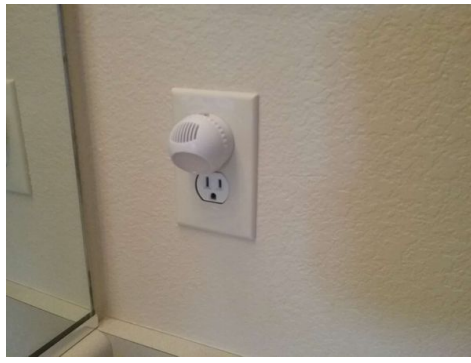
#### 6.5.1 GFCI & AFCI

### **NOT PRESENT IN THE BATHROOMS WHERE THEY ARE REQUIRED**

MASTER BATHROOM , 2ND FLOOR HALLWAY BATHROOM

Even though the master and 1st floor bathrooms had GFCIs, the outlets listed above did not appear to be on these circuits. Without a GFCI, there is no mechanism to prevent an electrical short. Upgrade all receptacle to GFCI protection within 6 feet of all potential wet locations.

Contact a qualified electrical contractor.

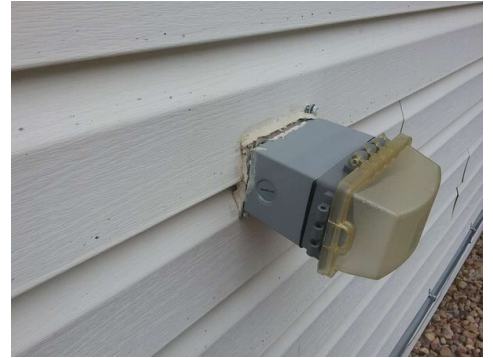
### 6.5.2 GFCI & AFCI

## OUTLET IS LOOSE

EAST EXTERIOR

Loose outlets can cause active wiring to touch the junction box, and spark or short-circuit the outlet. Properly secure the outlet.

Contact a qualified electrical contractor.

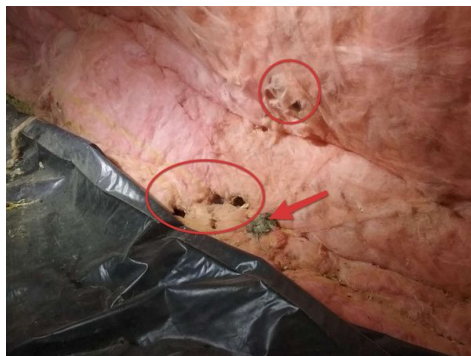
### 9.1.1 Insulation

## APPEARS TO HAVE SMALL BURROW HOLES SUGGESTING EXISTENCE OF RODENTS

CRAWLSPACE

The holes reduce insulation effectiveness and may get worse if the rodents are still present. Have a pest control company evaluate for treatment. In the possibility that there is an infestation, insulation and further remediation may be needed.

Contact a qualified pest control specialist.

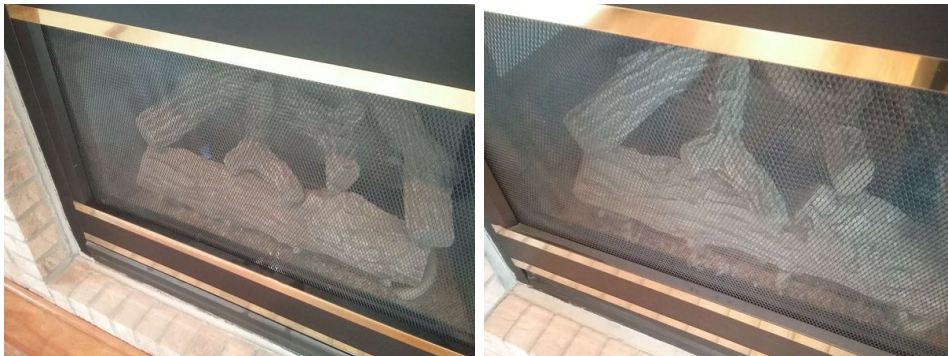
11.2.1 Fireplace/Wood Stove  
**NOT OPERABLE AT INSPECTION**

FAMILY ROOM (PILOT WAS ABLE TO BE LIT) , OFFICE

The fireplace does not appear to be fully completed/functional. This should be completed and made operational by a fireplace technician.

Recommendation  
Contact a qualified fireplace contractor.

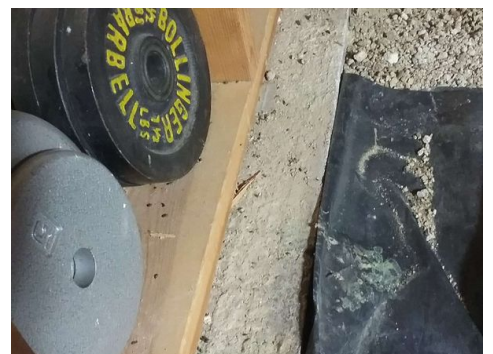
12.3.3 Floors  
**VERMIN ACTIVITY OBSERVED**

CRAWLSPACE

A pest control specialist should be contacted for proper clean-up and mitigation of the vermin. It is difficult to know the extent of the activity until this is further evaluated.

Recommendation  
Contact a qualified pest control specialist.

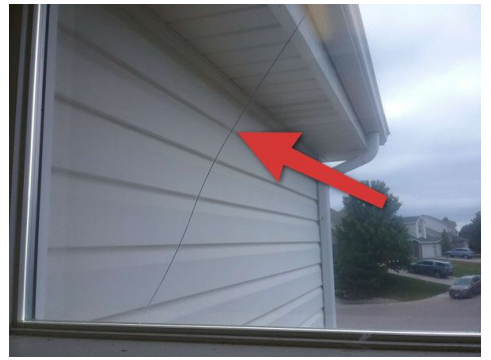
**GLASS PANE IS CRACKED OR  
BROKEN**

EAST BEDROOM

The cracks expose sharp edges and reduce protection from the elements. Replace the glass.

Contact a qualified professional.
