RESIDENTIAL REPORT

1234 Main St. Centennial Colorado 80112

06/23/2021 9:00AM

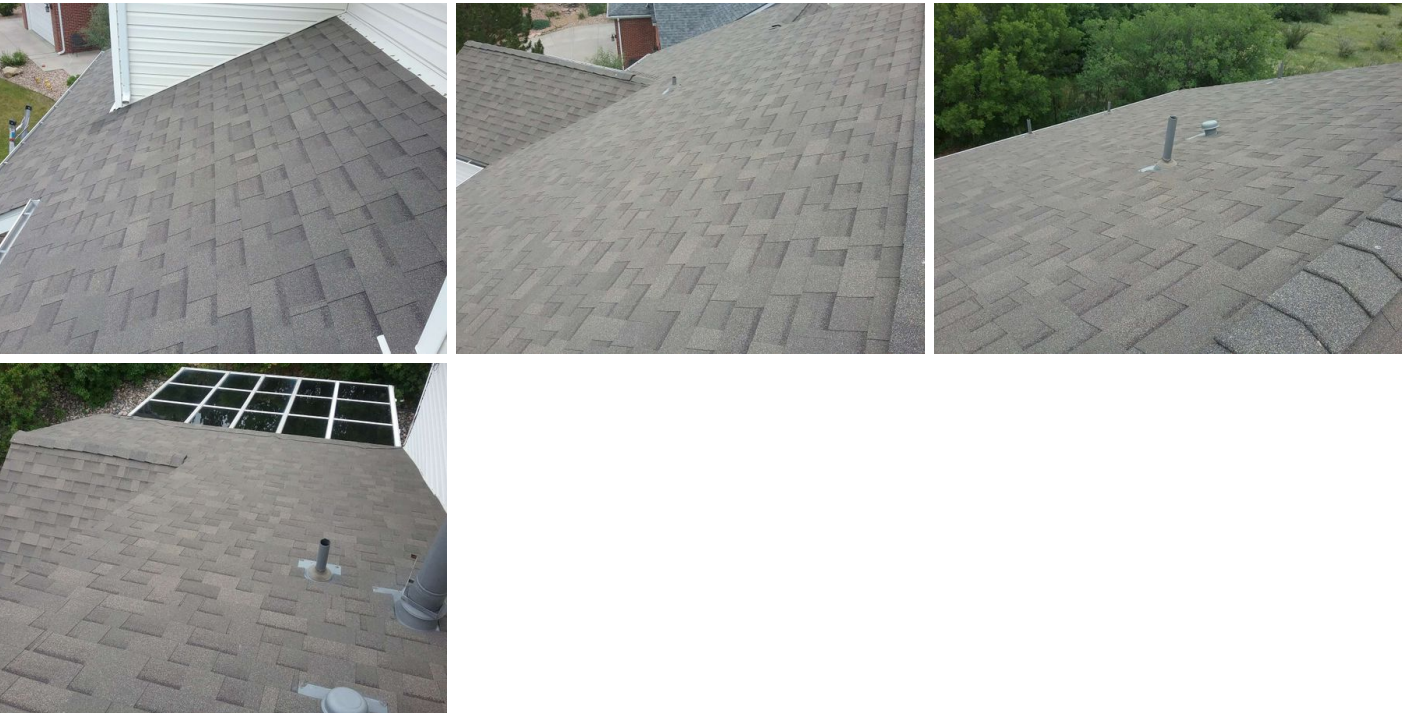
Coverings: Warranty information needed

As the roof appears to have been recently replaced or installed, obtaining any warranty information as well as if this is an impact resistant roof from the current owner is recommended.

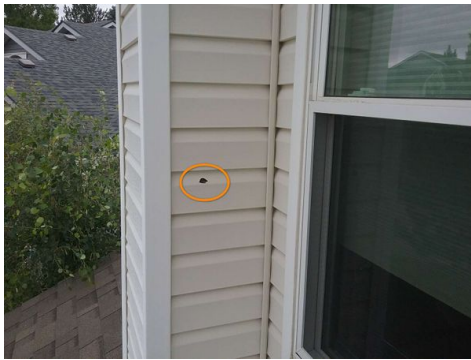
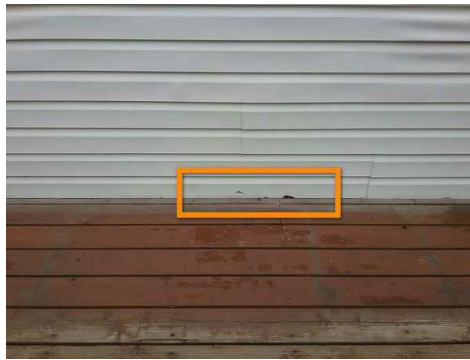
VINYL SIDING OR TRIM DAMAGED

This can allow moisture to get back behind the vinyl siding. Damaged pieces of siding material should be replaced.

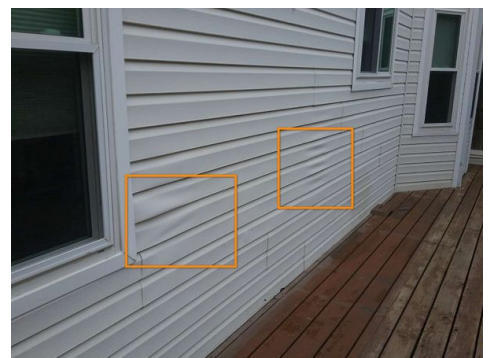
4.5.5 Siding & Trim

VINYL SIDING OR TRIM HAS MELTED

With damaged siding, the under sheathing has no protection from the damaging effects of the elements. Replace the damaged siding.

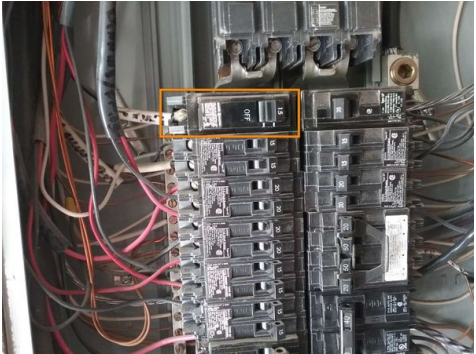
It appears that circuit breakers have been used in the panel that are different manufacturer than the panel manufacturer. Not all breakers are inter-changeable, and if not designed for the panel, a breaker can come loose and cause arcing. A certified electrician should determine if these breakers are allowed to be used in this panel.

Recommendation
Contact a qualified electrical contractor.
